From: Investigating Officer, Marine Safety Office Anchorage
To: Commander (d), Seventeenth Coast Guard District
Via: Commanding Officer, Marine Safety Office Anchorage

Subj: CLASSIFIED FISH PROCESSING VESSEL GALAXY (D576981) EXPLOSION,
FIRE AND SINKING IN THE BERING SEA WITH TWO PERSONS DECEASED
AND ONE PERSON MISSING AND PRESUMED DEAD

1. EXECUTIVE SUMMARY

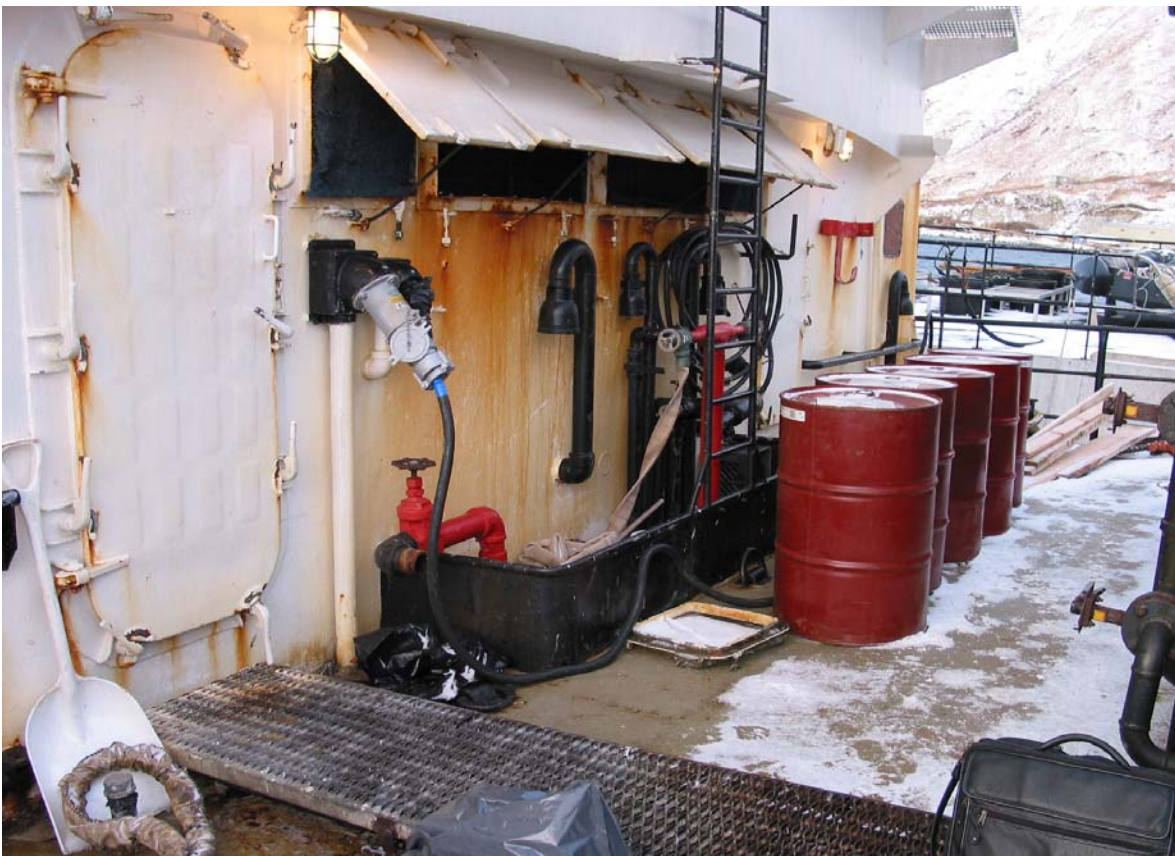
Figure (7): Photo of Previous Ventilation Closures for Engine Room taken December 2001

Ventilation: The engine space was equipped with both supply and ventilation fans. The engine room vents were located on the forward wheelhouse bulkhead. There was also a ventilation fan on the upper stack. The engine room ventilation closures were altered in 2002. The original design, shown in Figure (7), closed by simply moving the support arm out of the way and allowing the cover to drop down into place over the ventilation duct. With the new installation, fabricated inserts had to be dropped down into place by reaching inside the vent cowling.

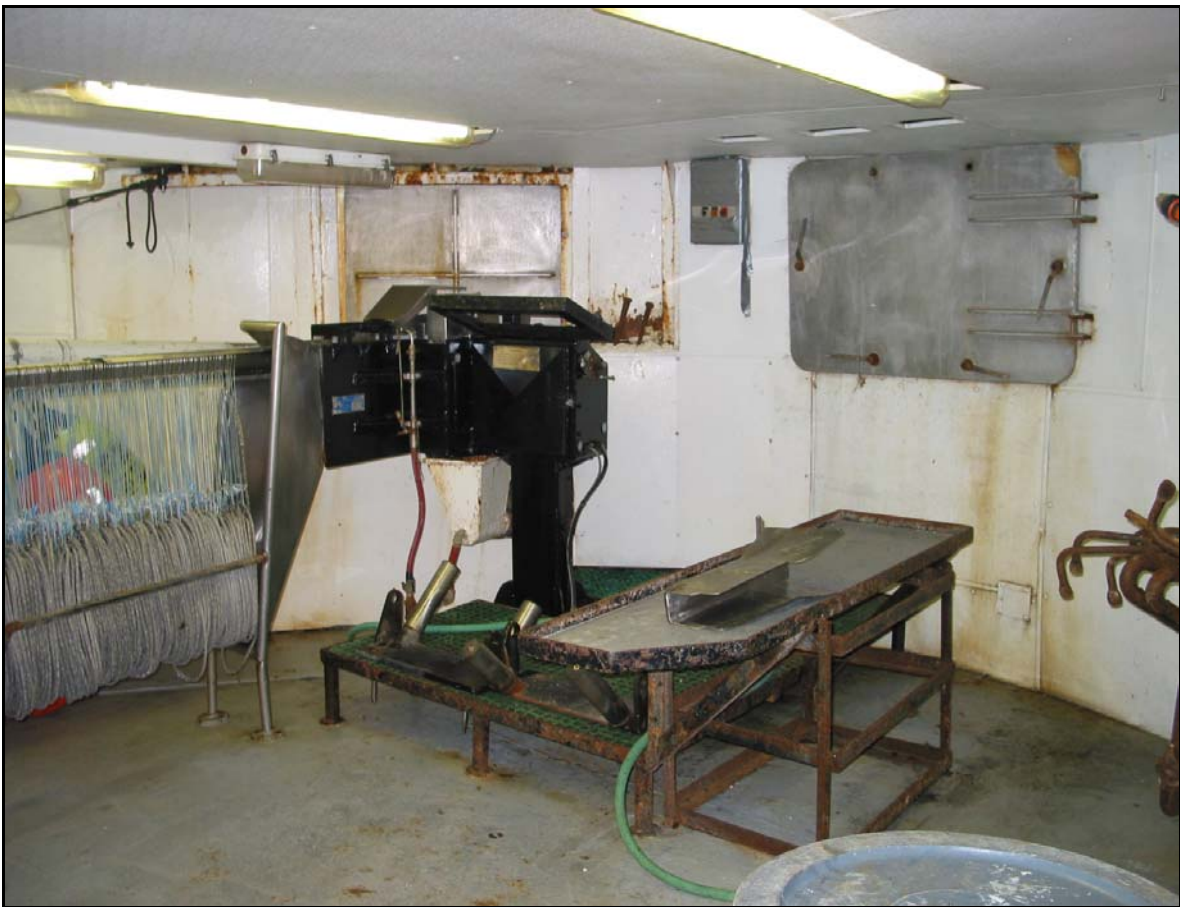
Figure (17): Photo of Gear Setting Hatch taken December 2001

~1626 (Gear Setting Hatch) A photo of the gear setting hatch is provided in Figure (17) below. The three fire team members were positioned at the gear setting hatch, trying to get fresh air. Ryan Newhall testified that the fire team members knew they were in a bad situation. They were in the process of attempting to evacuate the space by climbing up the stern of the vessel with lines provided by the crew on the top deck. Mr. Newhall and Mr. DeNuccio testified that they had made contact with Mr. Pigott, who was in the process of retrieving lines for them. Mr. Newhall was standing on the starboard side of the hatch, Mr. Stephens in the middle, and Mr. DeNuccio on the port side. Mr. Newhall was standing on a table with his waist just above the level of the hatch. Mr. DeNuccio and Mr. Newhall testified that both Mr. Stephens and Mr. DeNuccio stepped back to grab the SCBA and then set it on the baiting table and were returning to hang out the hatch. Mr. DeNuccio and Mr. Stephens were immediately adjacent to the hatch, but not leaning out of it when an explosion occurred violently ejecting all three from the vessel and into the water.

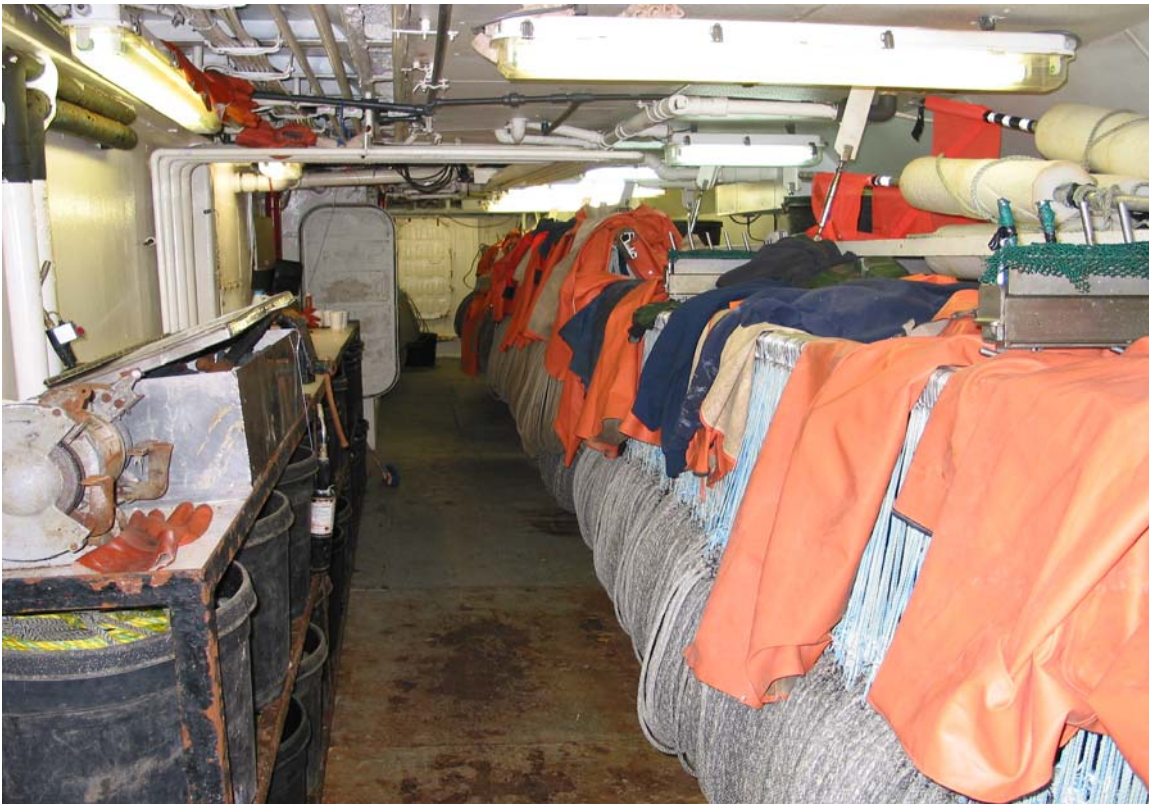
Figure (23): Photo of Gear Line Looking Forward towards Upper Engine Room Hatch (December 2002)

Fire Team Response: The crew of the FPV GALAXY were not trained, equipped or had experience as professional marine fire fighters. Based upon testimony, the vast majority of the fire team responded to the scene with hoses, extinguishers, SCBAs and fireman's outfits immediately following the detection of smoke and the activation of the fire alarm. Figure (23) is a view looking forward on the gear line.
